POPPLETON HISTORIC STUDY

850-868 W. Baltimore Street

B-2590 850-868 W. Baltimore Street Sanborn Map Baltimore City Baltimore 1890 vol. 3, Sheet 82_a

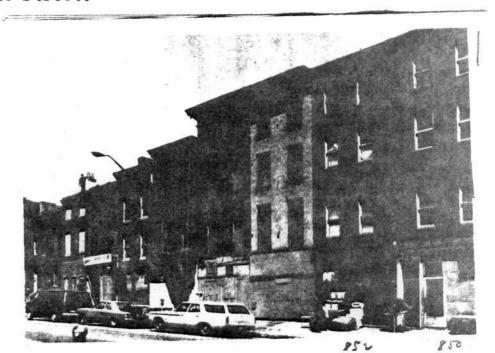
Numbers 854-856 are a matched pair with single cornice, four stories tall and of good proportions. Houses to the east --850-852 -- have a new front but were probably originally the same design as 854-856. All four houses were later than the others and may have been built at the site of the open yard in front of the Winans' office which shows on the Sachse view. in the approximate location of 847/853 W. Fairmount Avenue.

All but two, 850-852, of these are vacant and boarded up; commercial blight is rampant. The terrace is part of a row of many original shop fronts which should be restored and used. The original brick has been damaged in some cases; the repairs at 850-852 are an example. There is an open space at the south side of the street.
